Corozal Metric for Intersection Improvement and Implementation: A Tool to Improve Vulnerable Road User Safety in a Developing Country

Logan Proffer¹
Matthew Vechione¹
Mena Souliman¹
Yanira Olivares-Ortiz¹
Wesley Hickey¹

Abstract

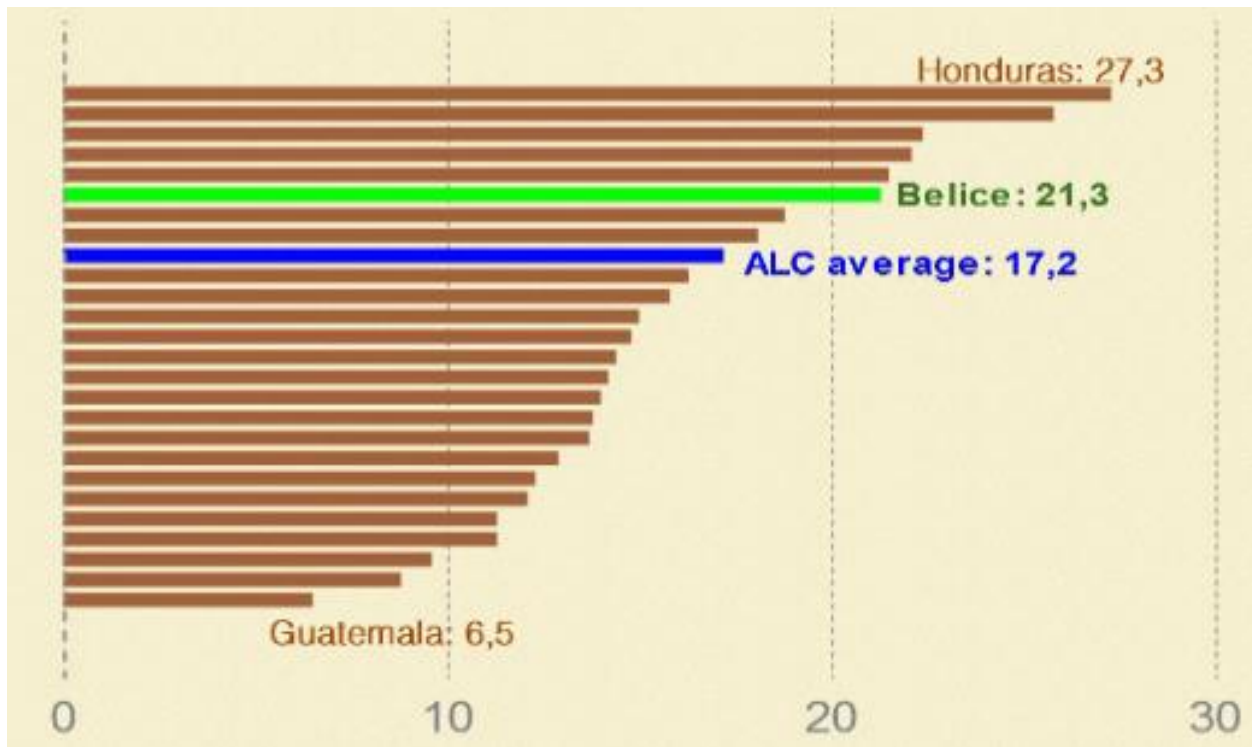
FIGURE 1 Road fatalities per 100,000 population in Latin America and the Caribbean in 2012 (2).

Among the countries in this region that is plagued with roadway-related fatalities is Belize. With 21.3 road fatalities per 100,000 population in 2012, Belize is significantly above the average for Latin America and the Caribbean. Figure 1 presents the road fatalities per 100,000 population in Latin America and the Caribbean.

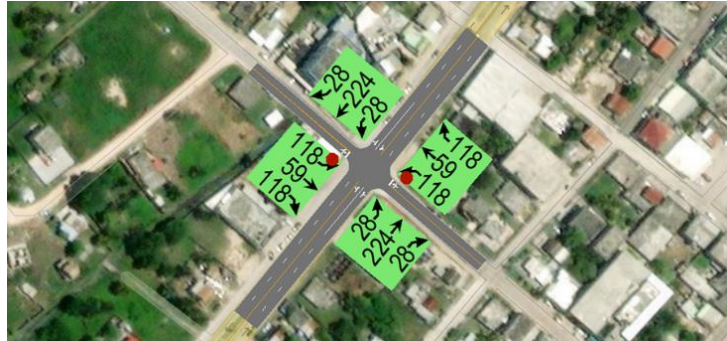
FIGURE 4 Example of Intersection 3 Modeled in Synchro (7).

After examining the traffic counter data, the next step was to develop a microsimulation and macrosimulation model to determine the operational performance of each intersection as well as the performance of the town of Corozal as a whole. The microsimulation models of each intersection were done in Synchro (7), while the macrosimulation model of the entire network was done in VISSIM (8). Using the peak day and peak hour volumes presented in [Table 4](#), each intersection was imported into Synchro in order to determine the existing level of service (LOS). The LOS results for each intersection are presented in [Table 5](#). Furthermore, an example of Intersection 3, as modeled in Synchro, is presented in [Figure 4](#).

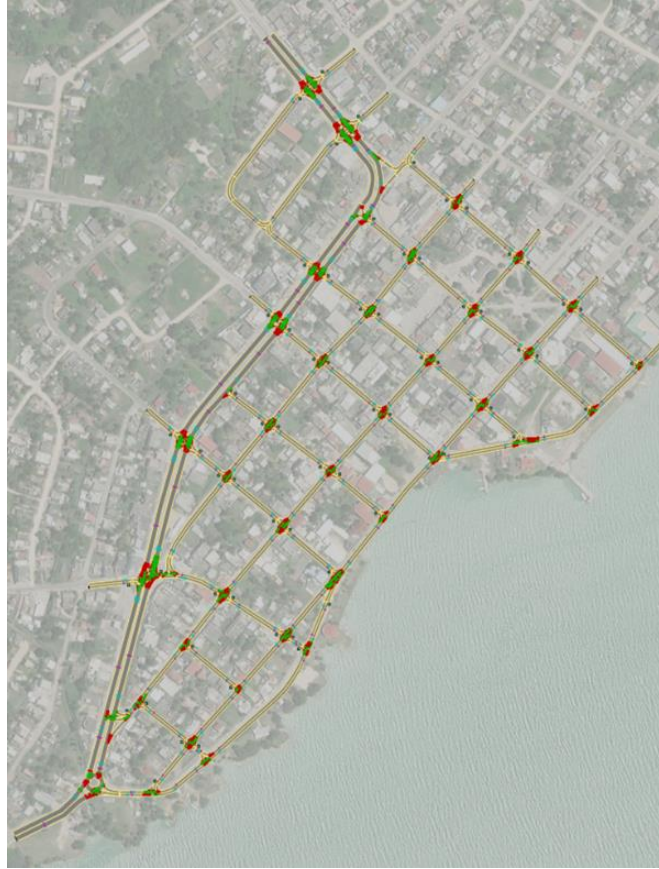
The VISSIM model was used as a *macroscopic* simulation model to assess overall traffic patterns within of the entire town of Corozal. It should be noted that this macroscopic model cannot be used for intensive analysis due to the limited data at only six intersections within the town. The VISSIM model can, however, be used to see how a change to an intersection (e.g., installing a signal or converting an intersection to a roundabout) affects the town of Corozal as a network. Furthermore, the macroscopic model may be used for visualization purposes for the public, in order to show improvements since the first VRU fatality occurred. [Figure 5](#) presents an overview of the macroscopic VISSIM model.

FIGURE 5 Town of Corozal in VISSIM (8).

In addition, a macroscopic VISSIM model was created, which considers the entire town of Corozal as a network. It should be noted that this macroscopic model cannot be used for intensive analysis due to the limited data at only six intersections within the town at the time of this study. The VISSIM model can, however, be used to see how a change to an intersection (using the CMI3 tool) affects the town of Corozal as a network. In the meantime, the macroscopic model may be used for visualization purposes for the public.
